STATEMENT OF DEFICIENCIES AND PLAN OF CORRECTION		(X1) PROVIDER/SUPPLIER/CLIA IDENTIFICATION NUMBER: HAL034016	(X2) MULTIPLE CONSTRUCTION A. BUILDING: 01 B. WING: _____		(X3) DATE SURVEY COMPLETED 07/22/2015
NAME OF PROVIDER OR SUPPLIER VIENNA VILLAGE		STREET ADDRESS, CITY, STATE, ZIP CODE 6601 YADKINVILLE ROAD PFAFFTOWN, NC 27040			
(X4) ID PREFIX TAG	SUMMARY STATEMENT OF DEFICIENCIES (EACH DEFICIENCY MUST BE PRECEDED BY FULL REGULATORY OR LSC IDENTIFYING INFORMATION)	ID PREFIX TAG	PROVIDER'S PLAN OF CORRECTION (EACH CORRECTIVE ACTION SHOULD BE CROSS-REFERENCED TO THE APPROPRIATE DEFICIENCY)		(X5) COMPLETE DATE
C 000	<p>Initial Comments</p> <p>Report of Biennial Construction Survey by Dennis Harrell and Bob Getchell on 7-22-2015.</p> <p>Records indicate the middle portion of this facility was first licensed or submitted as a Home for the Aged on 3-1-1966. Therefore the middle of the facility must meet the 1967 NC State Building Code, the 1971 Minimum and Desired Standards and Regulations for Homes for the Aged and Infirm and the applicable portions of the 2005 Rules for the Licensing of Adult Care Homes of Seven or More Beds.</p> <p>The right end of the facility was built in 1985

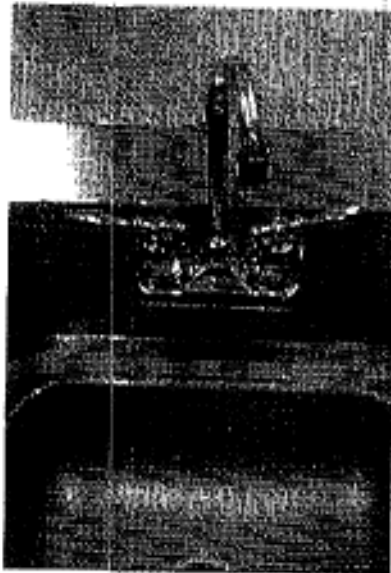
C 144	Med Prep Area-Sink with Lever Handles SECTION .0300 - PHYSICAL PLANT 10A NCAC 13F .0305 PHYSICAL ENVIRONMENT (f) The requirements for storage rooms and closets are: (5) Handwashing facilities with wrist type lever handles shall be provided immediately adjacent to the drug storage area;	C 144

Installed on 7/23/15
